CORROSION SURVEY

Vessel Details		Name MY "XXX"
Manufacturer Bayliner		Model 4387 Aft Cabin
LOA [Ft] 44	Year 1993	Hull Material Fiberglass

Report No 2017/0031
Date 28.09.2017

Reason for Survey Diver reports corrosion on engine inlet strainers

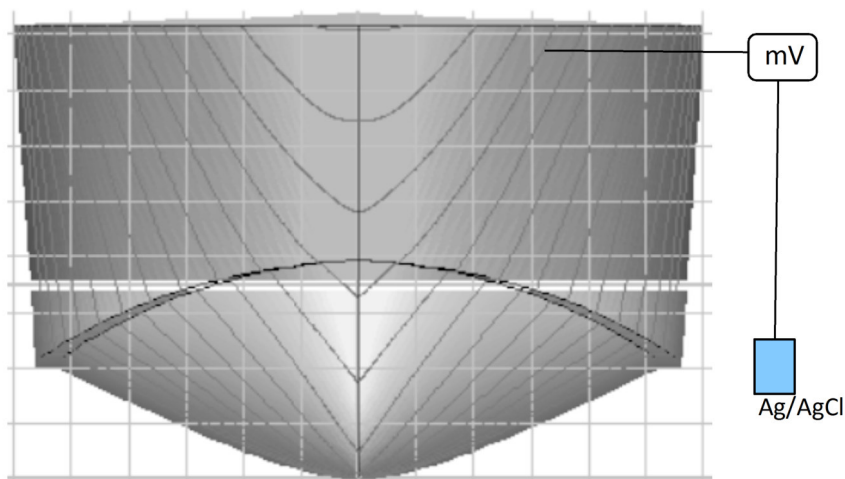
Hull Potential and Bonding System

Aft	450
Amidships	X
Bow	X

Bonding installed	Yes
Galvanic Isolator	No
Isol. Transformer	No
Faults detected	Yes

Bonding not soldered or sealed and heavily corroded. Bonding wire broken between both engines and cooling intakes. Approx. 10 cm of water in Bilge. Aft bilge pump shows stray current readings of 1,023-1,030 Volts when in operation. Stbd. shaft packing leaking.

**Rebonding of all UW through Hulls required!
Solder and seal all bonding connections.
Re-wiring of AC ground to DC bonding required.
Renew aft bilge pump (isolation defect).
Renew both engine inlet strainers! High Safety Risk!**

Not mandatory: Corrosion Controller recommended
