CORROSION SURVEY

Vessel Details		Name MY "XXX"
Manufacturer Bayliner		Model 4387 Aft Cabin
LOA [Ft] 44	Year 1993	Hull Material Fiberglass

Report No 2017/0031
Date 28.09.2017

Reason for Survey Diver reports corrosion on engine inlet strainers

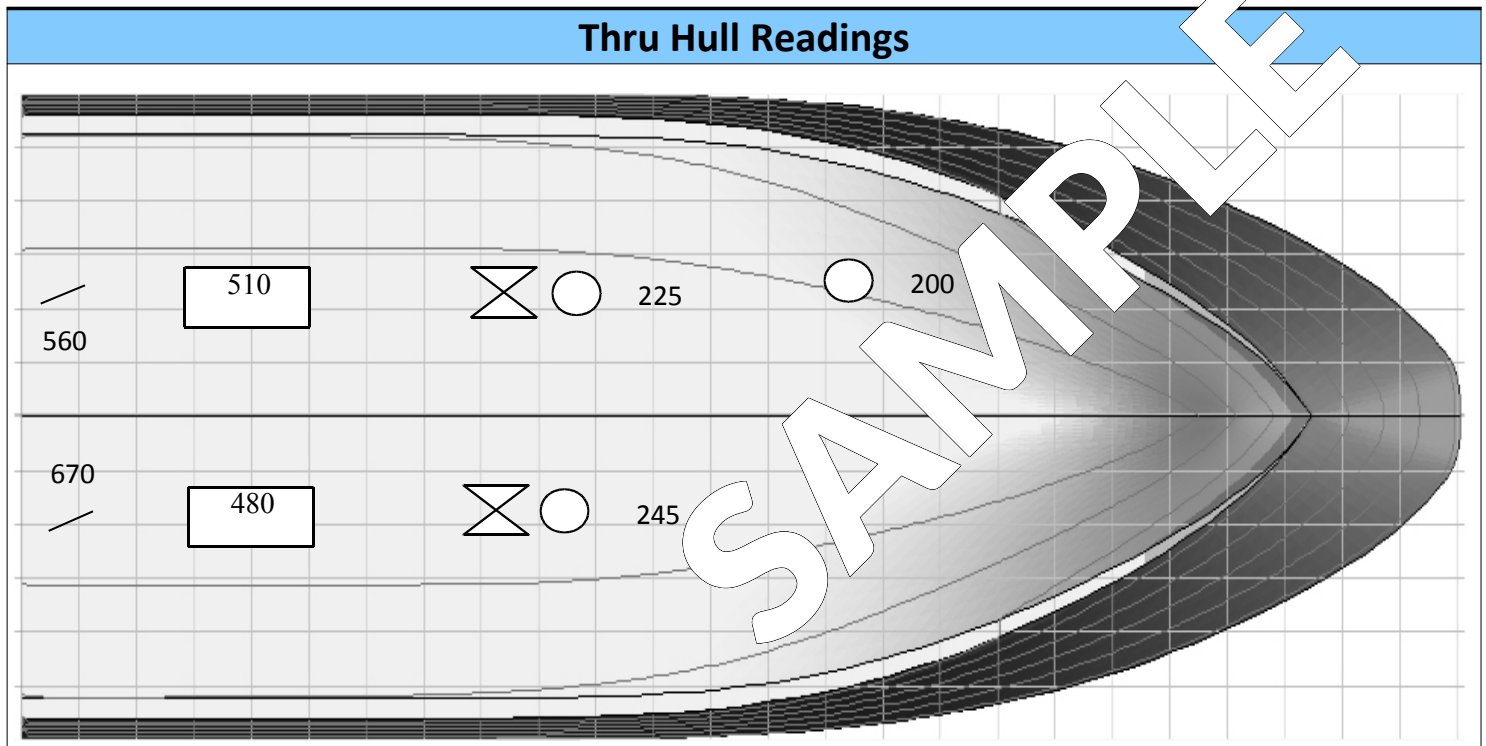
Hull Potential and Bonding System

Bonding not soldered or sealed and heavily corroded. Bonding wire broken between both engines and cooling intakes. Approx. 10 cm of water in Bilge. Aft bilge pump shows stray current readings of 1,023-1,030 Volts when in operation. Stbd. shaft packing leaking.

**Rebonding of all UW through Hulls required!
Solder and seal all bonding connections.
Re-wiring of AC ground to DC bonding required.
Renew aft bilge pump (isolation defect).
Renew both engine inlet strainers! High Safety Risk!**
